**DEPARTMENT OF TRANSPORTATION**

Contract #: 04-0120F4Cty: SF/ALA Rte: 80 PM: 13.2/13.9File #: 1.28**WELDING INSPECTION REPORT****Resident Engineer:** Siegenthaler, Peter**Address:** 333 Burma Road**City:** Oakland, CA 94607**Report No:** WIR-021327**Date Inspected:** 02-Mar-2011**Project Name:** SAS Superstructure**OSM Arrival Time:** 700**Prime Contractor:** American Bridge/Fluor Enterprises, a JV**OSM Departure Time:** 1600**Contractor:** American Bridge/Fluor Enterprises, a JV**Location:** Job Site

**Bridge No:** 34-0006**Component:** OBG Section**Summary of Items Observed:**

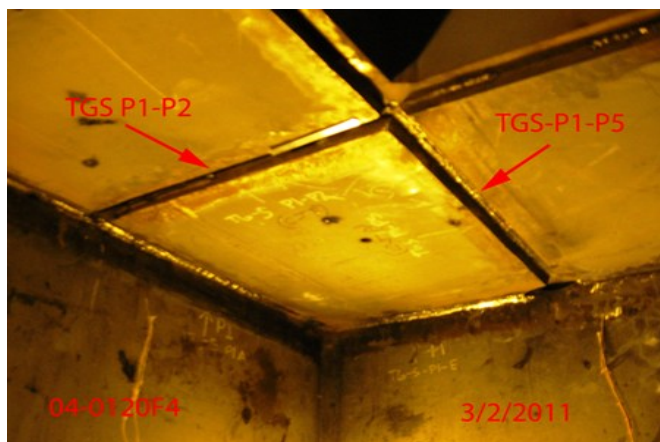
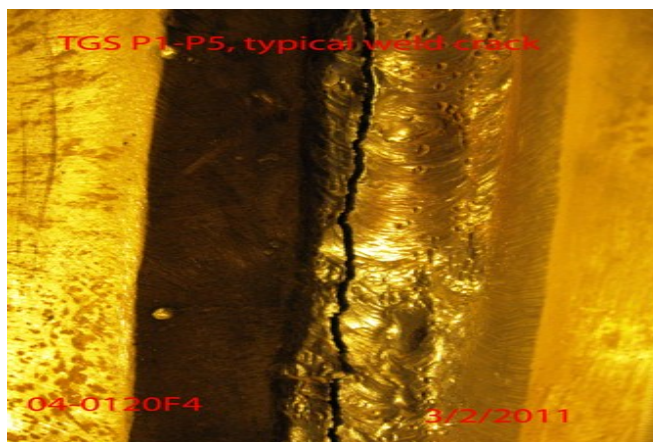
This QA Inspector was informed by QC Inspector Fred Von Hoff at approximately 0700 hours the root pass of two of the Complete Joint Penetration (CJP) welds had been visually inspected and Magnetic Particle Tested (MT) and cracks were observed at weld joints TGS P1-P2 and TGS P1-P5. This QA Inspector performed a visual verification and observed the following: (see typical photos below)

Weld Joint: TGS P1-P5: a crack was observed approximately the full length of the weld joint, 790 mm.

Weld Joint: TGS P1-P2: a crack was observed approximately 250 mm from the end of the weld joint (opposite the skin plate) and had a length of approximately 200 mm.

Later this date at approximately 1330 hours this QA Inspector performed a visual verification of the cracks previously noted and observed the width of both cracks had increased and that at TGS P1-P2 the length of the crack was now approximately 495 mm in length. At weld joint TGS P1-P5 the crack was previously noted as being full length. The growth in width and/or length was presumed to be due continued welding of the PJP weld joints.

no further weld/work was to be performed on the two weld joints with cracks, but to continue with production welding the PJP weld joints.
